SURFACE PROPERTIES OF MICROMACHINED POLYCRYSTALLINE SILICON STRUCTURES

Leslie Phinney, Joanne Wellman, Gisela Lin, Ron Ruiz, and Russell Lawton
Jet Propulsion Laboratory
August 2000

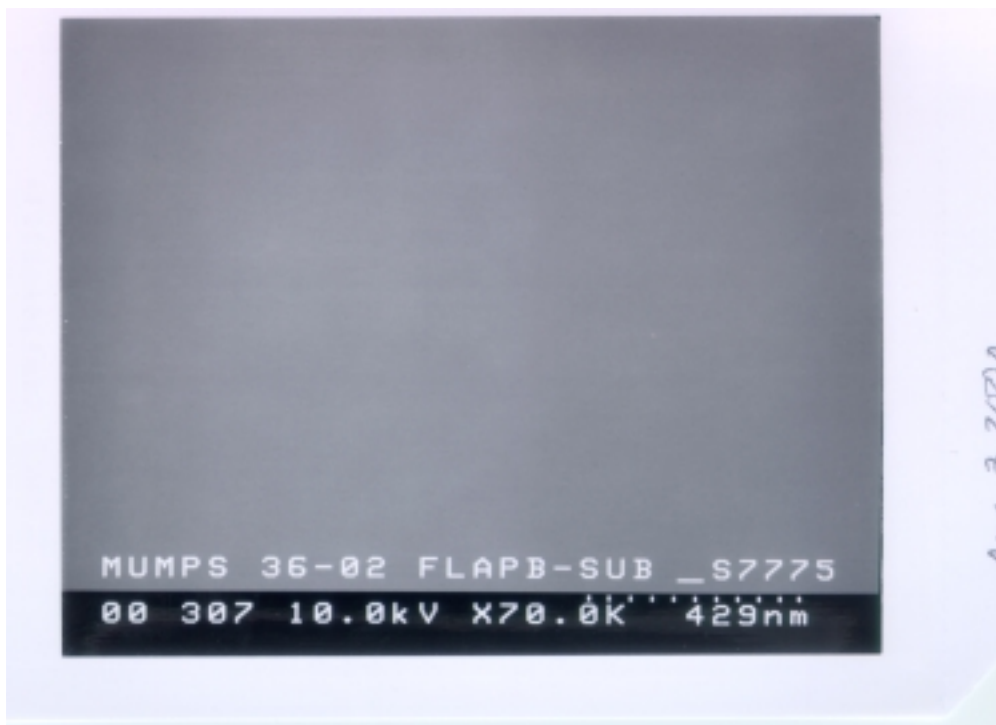
SEM of the bottom of a poly1 flap (above) and the silicon nitride under a flap (below) for a die released with a CO₂ supercritical dry process. The surfaces are in general pretty clean.

The CO₂ supercritical dry process produces polysilicon surfaces that are generally clean. The silicon nitride layer under the polysilicon flaps does have residues which need to be explored. There were some large residue droplets showing sodium and sulfur contamination in addition to fluorine residues. Also, several of the structures were broken during the CO₂ supercritical dry process, or more likely, transportation of the chip after drying.

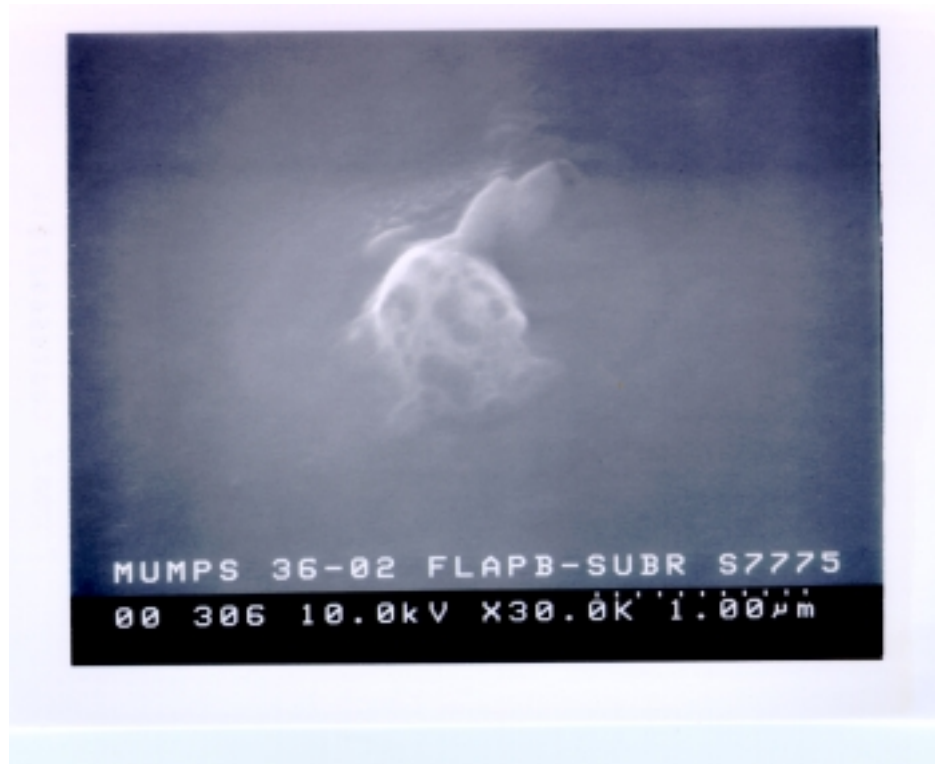
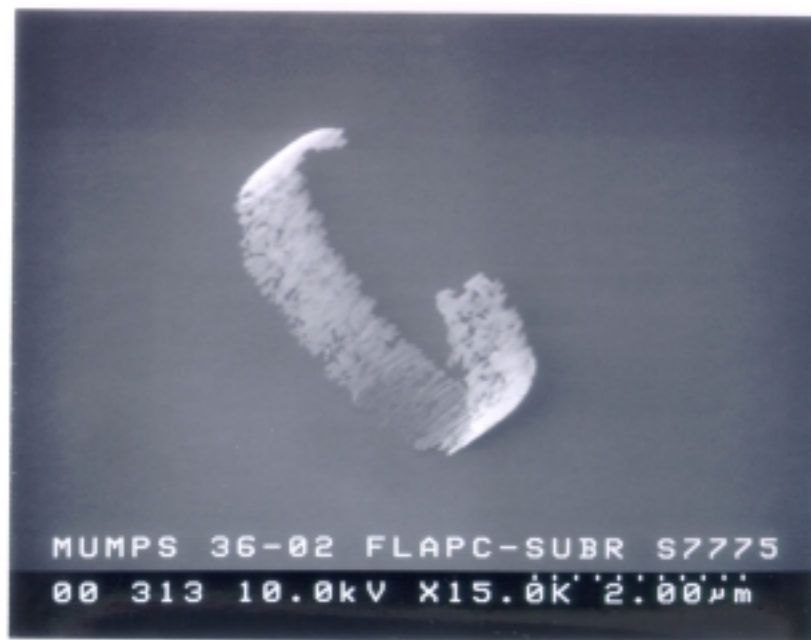
SEM images of residues on the silicon nitride layer below a poly1 flap for a die released with a CO₂ supercritical dry process. EDS of the top residue showed silicon, nitrogen, oxygen, sodium, and sulfur.
